# Manhole Inspection Summary

Manhole # S21EE\_040MH

Insp Date: **6/27/07 10:00 AM**

**Location** Address: **1410 MONROE ST**

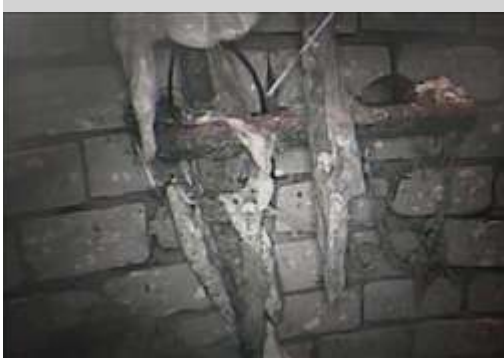
Defect 3

☒ **Evidence Of Surcharge**

Depth: **4** (ft.) ☐ Active Surcharge Present

SURCHARGE EVIDENCE ON STEPS

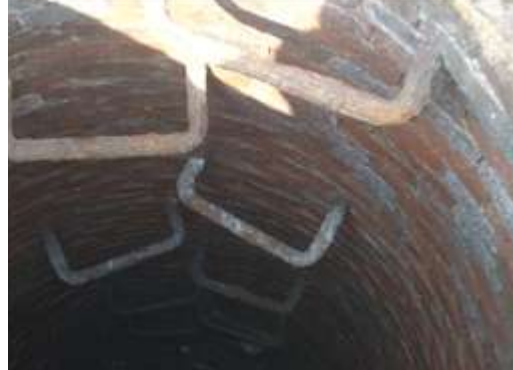
Defect 2

Count: **11** Missing: **0** ☒ **Corroded**

CORRODED STEPS

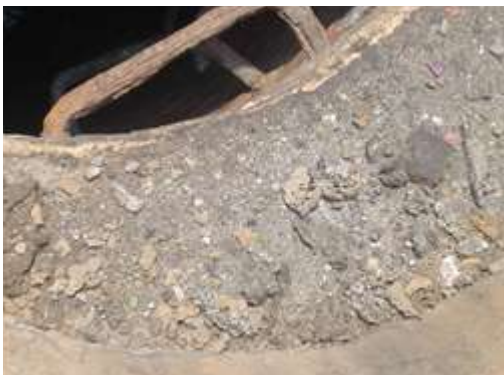
Defect 1

Offset: **8** (in.)

MAJOR FRAME OFFSET

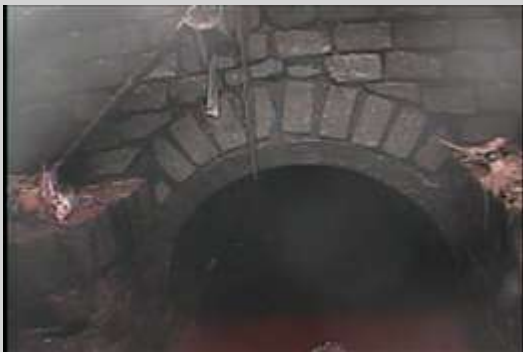
12 O'Clock Outflow

24 in. Circular Gravity Sewer  
Pipe Out @ 12 O'Clock

Pipe Height: **24** (in.) Rod and Bar (Angled)  
Pipe Material: **Clay** ☐ Pipe Lined  
Invert Depth: **18.22** (ft.) Flow Characteristics: **Slow**  
Deposits: ☒ None ☐ Mud ☐ Sludge ☐ Debris ☐ Grease  
Silt Depth: (in.) Deposits Extent:  
Infiltration: **None** Pipe Seal Cond: **Sound**

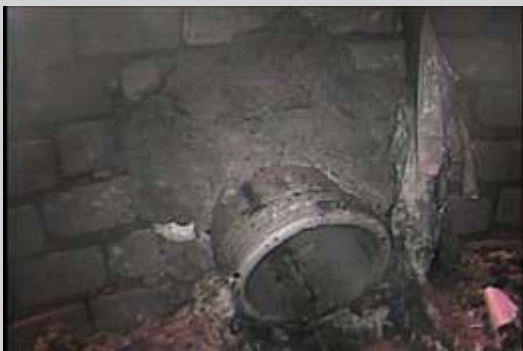
3 O'Clock Inflow

8 in. Circular Gravity Sewer  
Pipe In @ 3 O'Clock

Pipe Height: **8.4** (in.) Rod and Bar (Angled)  
Pipe Material: **Clay** ☐ Pipe Lined  
Invert Depth: **16.05** (ft.) Flow Characteristics: **Slow**  
Deposits: ☒ None ☐ Mud ☐ Sludge ☐ Debris ☐ Grease  
Silt Depth: (in.) Deposits Extent:  
Infiltration: **None** Pipe Seal Cond: **Sound**

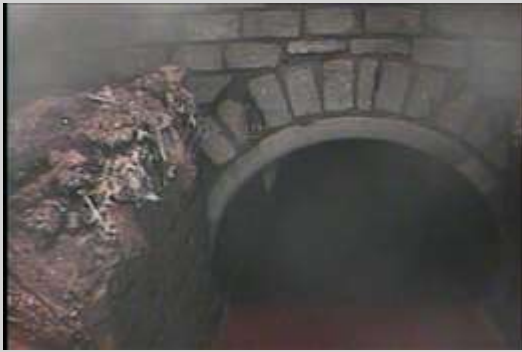
6 O'Clock Inflow

24 in. Circular Gravity Sewer

Pipe In @ 6 O'Clock

Pipe Height: **24** (in.) Rod and Bar (Angled)

Infiltration: **None** Pipe Seal Cond: **Sound**

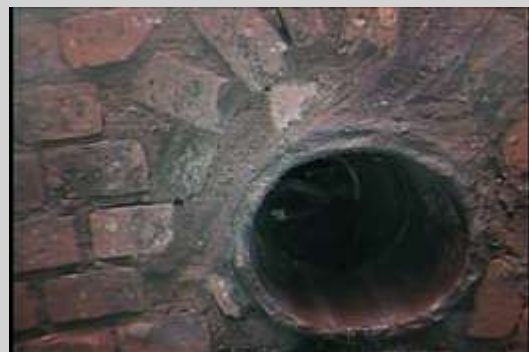
Drop In @ 9 O'Clock

Drop: **Outside** Rod and Bar  
Angled: **Yes** Reading: **15.99** (ft.)  
Inv Depth: **16.99** (ft.)  
Drop Condition: **Open**
